OHS ALERT

OCTOBER 2024

CRANE INCIDENT!

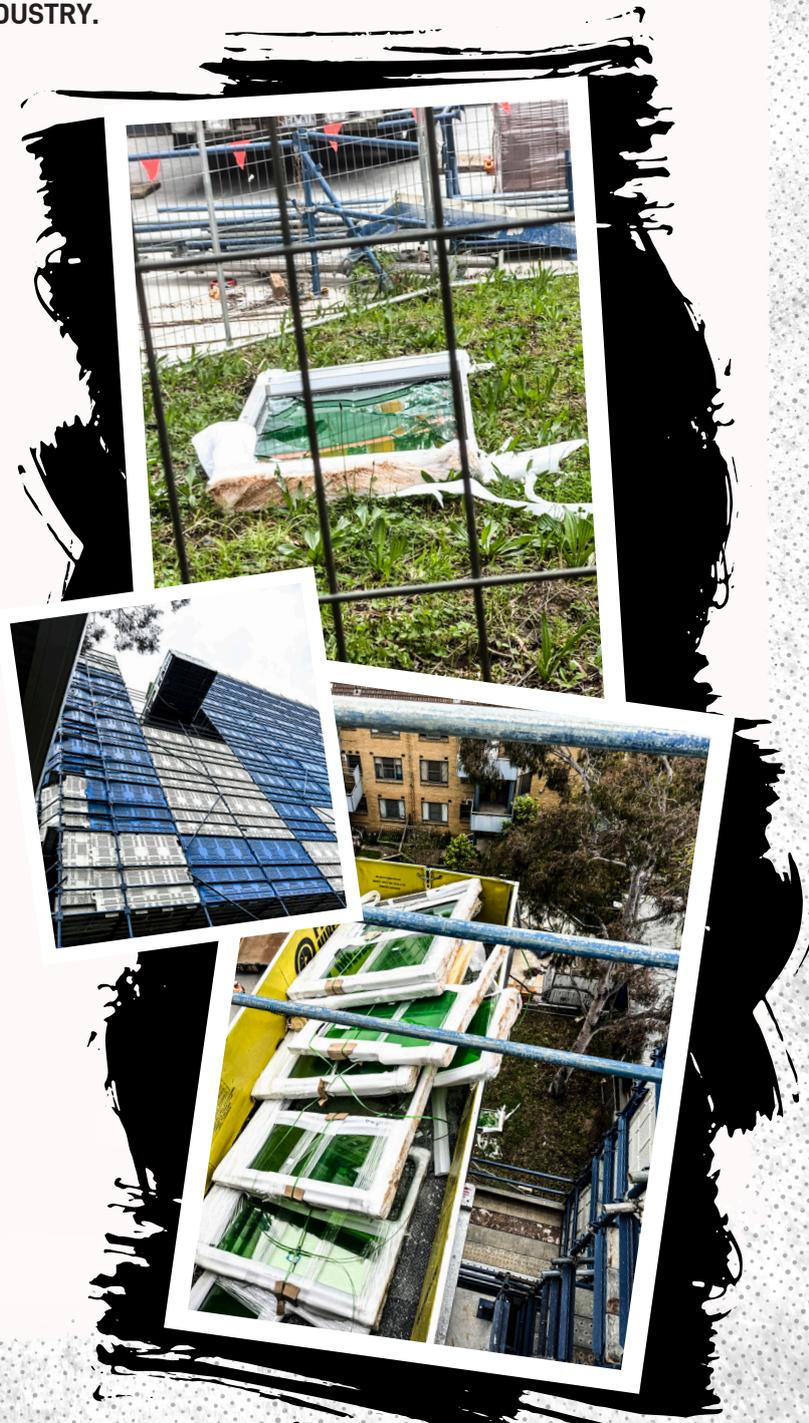
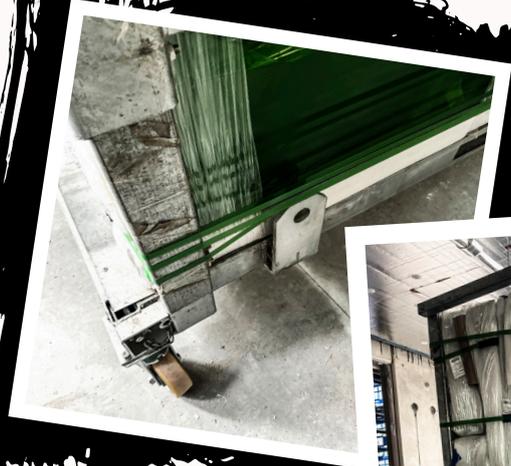
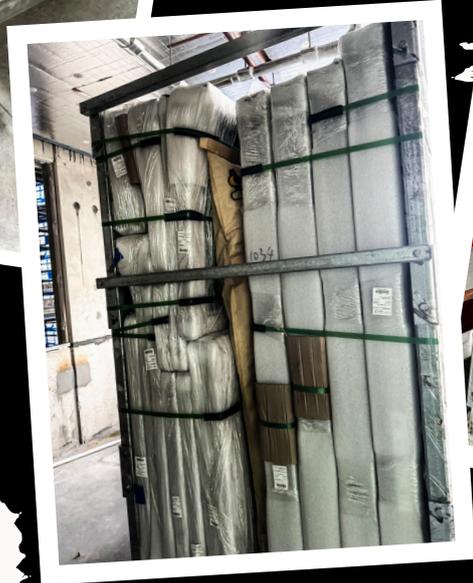
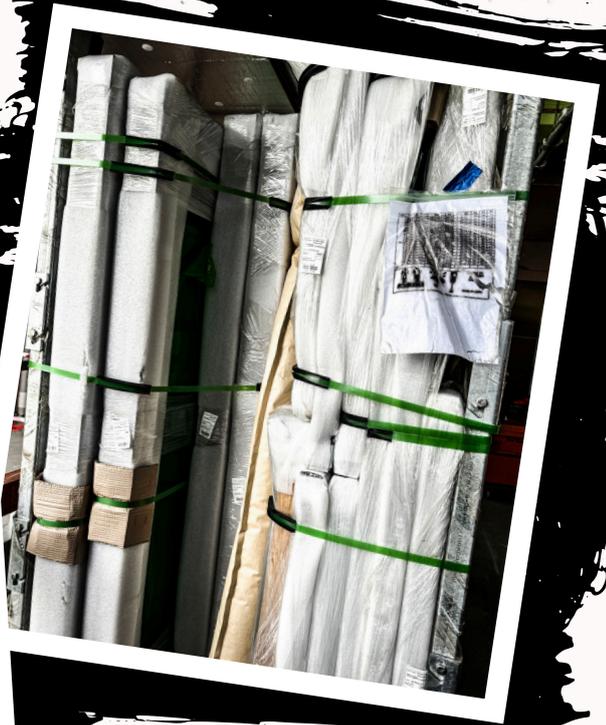
In this case, a tower crane was lifting a stillage of window frames - pre-glazed/fitted with glass windows, from the top of the building (Level 5) into a craneloading bay located on the floor below. The stillage somehow hit the top of a scaffold guardrail, tilted and the result was that the 10 or more pre-glazed window frames fell out of the stillage and luckily, landed in the crane loading bay located on Level 4 of the building. However, one frame did fall uncontrollably approximately 10-15 meters smashing onto the ground - and by pure luck, landing in a "tree" protection zone - narrowly (and luckily) avoiding two workers who were nearby.

The stillage itself was not fit for purpose and had serious design flaws. The stillage did not have protective bars all around the stillage, to prevent the glass from falling out of the stillage if the stillage was tilted at a particular angle - as it was in this case!

The frames/glass had been loaded so tightly into the stillage, that it was physically impossible to fit the chain hooks around the predesigned lifting lugs. This forced the crane crew to "come up with/invent" their own method to fix the hooks/chains onto the stillage so it could be lifted.

All the stillages loaded with the window frames appeared to be "overloaded" when they came to site. The "exclusion zone" around the lifting zone and the crane loading bay, should have been much larger in size to better absorb any errors, failures or unplanned variations in the work procedure. Both the subcontractor and the major contractors' SWMS on the lifting task, bore little or no resemblance to the work that was actually being conducted on this particular site, with this particular equipment, under the particular circumstances on the day.

- Always ensure that any lifting lugs can be safely accessed and used in accordance with their design specifications. If not – do not proceed with the lifting procedure. Do not attempt to “redesign” or lift in another manner until a full and comprehensive review has occurred with the appropriate management representatives and workers and their OHS representatives. Ensure “official” written authorisation has been approved or given by site management to lift the load in a “different manner” than originally planned.

- Ensure the SWMS accurately reflects the lifting procedures to be undertaken at your particular workplace, with the particular plant and equipment utilised for the task, at the particular time of the lift/s.

- Ensure all lifting stillages are safe, fit for purpose and suitable for the particular task in which they are to be used. Do not overload the lifting stillages. Ensure all loads within the stillage are secured and cannot fall uncontrollably out of the stillage in the event that the stillage is inadvertently tilted or offset.

- Ensure any lifting/landing “exclusion zones” are large enough to absorb any errors or failures during the lift. This includes positive and mechanical guarding and staffing to ensure the exclusion zones are fully adhered to and implemented.
