**Workplace Health and Safety Queensland**  
**Yongmao Hoist Rope Swivel Incident**  
Document date: 12 June 2025

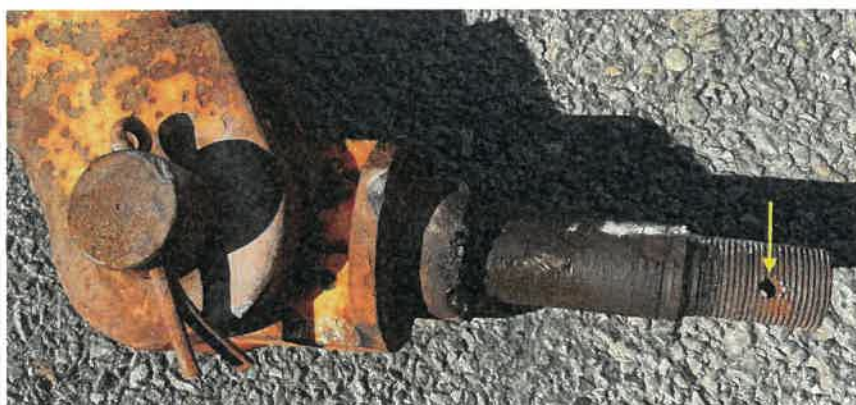
3. The hoist rope was found to be intact, however early inquiries indicate the retaining nut from the rope termination swivel appears to have unwound so that the swivel and rope termination disconnected. Normally, assuming the swivel is operating as intended, a split pin would pass through a castellated retaining nut and the male threaded section of the swivel (refer Figure 1) to prevent the nut winding off. One type of hoist rope swivel termination assembly used on Yongmao tower cranes is shown in Figure 2 (design differs to that involved in the incident).

**Figure 1** – Intact male threaded section on swivel (split pin passes through hole)

5. All hoists rope terminations on Yongmao tower cranes need to have their hoist rope anchorages inspected and split pins replaced as a ***matter of urgency***. This includes both two and multiple fall examples irrespective of whether the hoist rope is terminated at the boom tip or on the hook block.

7. Split pins should be replaced with brand new split pins that comply with the tower crane manufacturer's specifications (i.e. size, material type and grade and protective coating).

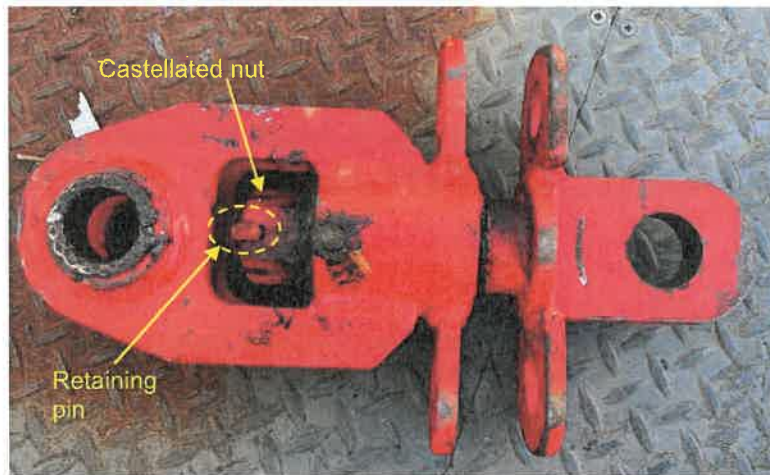
**Figure 2** – One example of a hoist rope termination swivel showing castellated nut

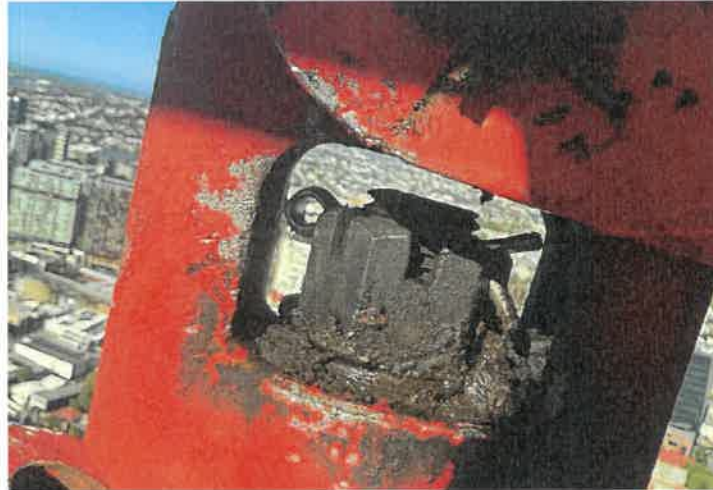
**Figure 3** – Photograph showing new split pin installed through castellated nut

8. A photograph should be taken of the brand new installed split pin. A signed inspection certificate completed by the senior rigger involved in the inspection should also be provided to site management. Figure 3 shows a new split pin installed on a castellated nut.
