# OHS ALERT

APRIL 2023

## HOARDING HORRORS

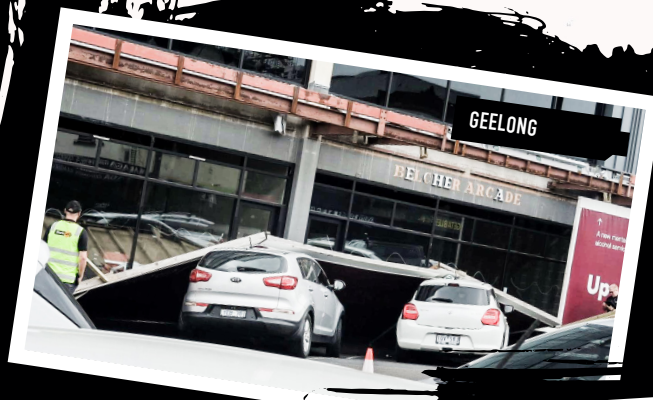
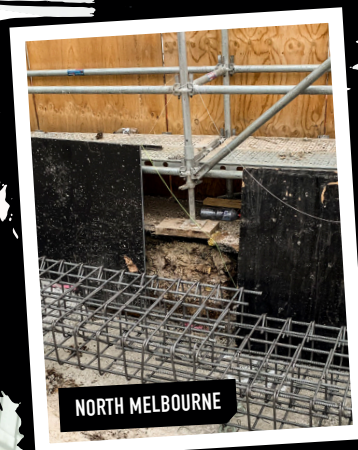
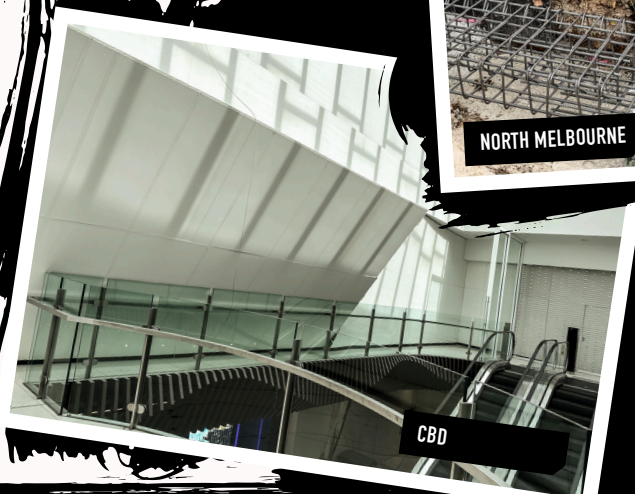
Two incidents early in the year narrowly missed someone being seriously injured or killed. An under engineered hoarding came down in Geelong narrowly missing a pedestrian and damaged several parked vehicles. Another in North Melbourne, where the hoarding was connected to a scaffold and the builder had excavated under the internal legs supports, caused the hoarding and scaffolding to fall internally.

A third incident occurred in the CBD where a hoarding was erected on level 4 to prevent falling objects coming down the atrium void. When a fire alarm was set off, the shopping centres' smoke extraction system engaged causing a vacuum effect and sucked the hoarding away from it's supports, onto the atrium void, coming to rest on a glass handrail/balustrade.

There are two sets of standards for hoarding protection: One for external use and one for internal use. We must ensure that the design of any hoarding has taken into consideration any and all possible events that may compromise the structure and/or injure any persons. Make sure the hoardings on your job can stand up against any and all circumstances and variables.
