Failure of bolts on Satellite Concrete Placing Boom

May 2009

OH&S Bulletin

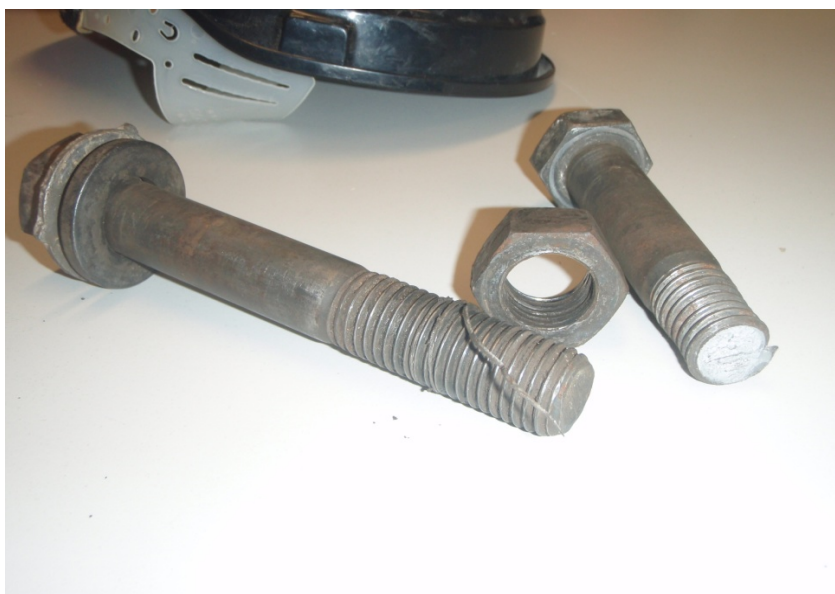
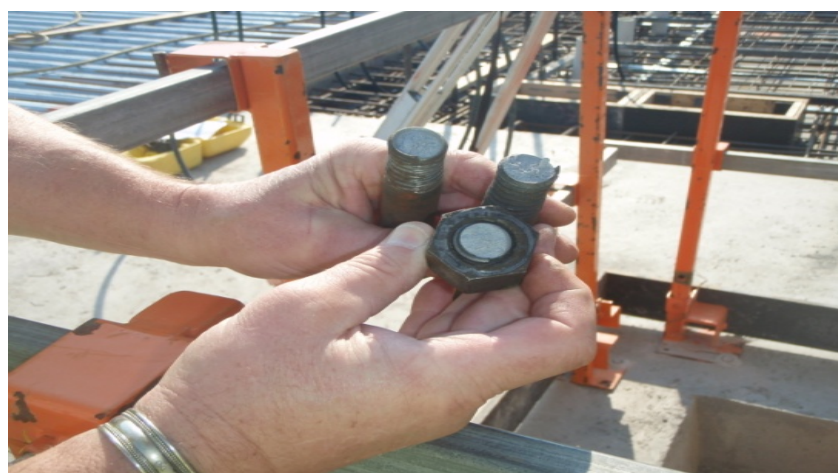
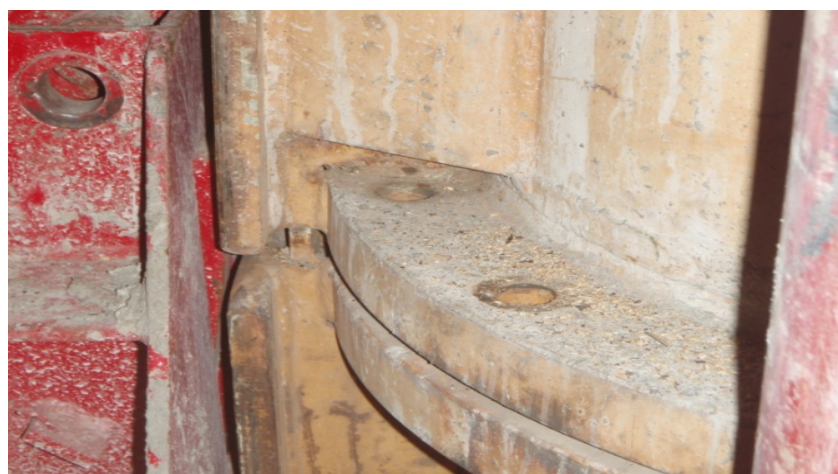
Recently on a Docklands construction site, there was a failure of a number of high tensile bolts used to hold together the upper vertical column splice joint of the satellite concrete placing tower boom; causing the column to come to rest and lean against the concrete slab.

Investigations revealed that the nuts and bolts may not have been the correct combination and may not have been set to the correct torque tensioning for each bolt; resulting in the nut tearing the thread away from the bolt and coming loose. The bolts had been used a number of times, and were of questionable suitability and integrity for the purpose of holding together such a high pressure and load induced piece of equipment.

- ✓ use new high tensile bolts and nuts every time the satellite boom is erected on site;
- ✓ ensure the engineer has specified the correct torque loadings for the bolt/nut combination;
- ✓ Always use bolts and nuts with the same proof load designs and strength combinations;
- ✓ Make sure all bolt assemblies are to Australian and DIN Standards,
- ✓ Ensure an engineer supplies a written compliance inspection of the unit that confirms that it has been built to the requirements of AS1418 and AS 2550, and is in a safe condition to use.
