JULY 2023 CFMEU SAFETY ALERT COLUMN REINFORCEMENT CAGE

FOLLOWING THE TRAGIC FATALITY OF A WORK STRUCK BY A FALLING COLUMN REINFORCEMENT CAGE, THE CFMEU HIGHLIGHTS THE FOLLOWING IN RELATION TO THE INCIDENT.

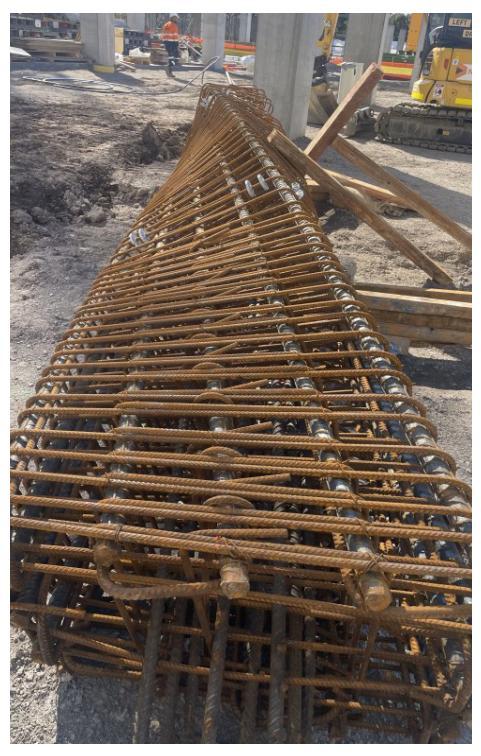
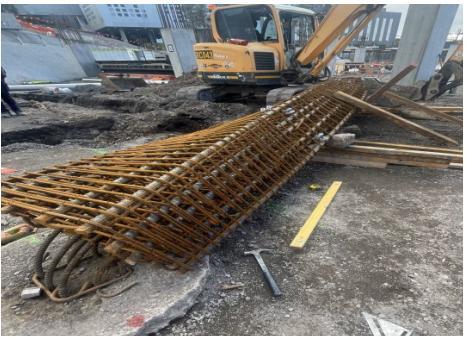
On 5th of July 2023, at the John Hunter Hospital Project, a 20 year old worker was struck by a falling prefabricated column reinforcement cage. The reinforcement cage weighed approximately1700kg and had a height of 7.7m. The injury was fatal.

- No exclusion zones were in place to manage the risk of other workers in the area who were preforming excavation works for inground services in the fall zone of the reinforcement cage. The deceased male was operating an excavator in the area when the cage fell.
- The reinforcement cage along with three other cages on the same gridline were left standing, without having column boxes installed and not braced to manufacturer's specification, on 8 x n24 starter bars which were protruding from below the pile cap by approximately 1460mm. The cage was secured only by tie wire after being vertically lifted into position by a Tower Crane.
- No measures were implemented to mitigate the risk of falling objects and or structural collapse of building elements.

- Failure to program activities onsite without risk to employees and to provide direct adequate supervision onsite to control the risk of falling objects.
- Incorrect installation method of reinforcement cage, including the use of aspro blocks and structural steel nuts as packers to support free standing reinforcement cages.
- Column boxes were not installed and braced once the cages were installed. There was a failure to follow construction sequence that was developed in the risk assessment process.
