# OHS ALERT

## PLASTERBOARD CARTS

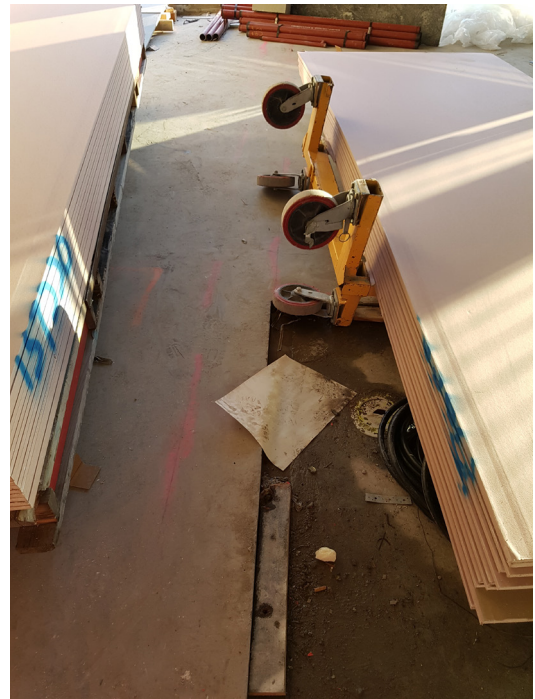
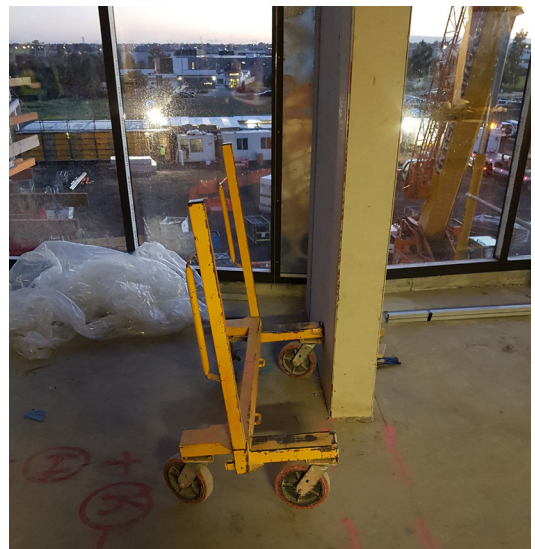
A worker has been hospitalised after a load, apparently under capacity for the plant, tipped and crushed him. The plant, a Telpro Panellift Plasterboard Cart manufactured by Intext, should not be used until further notice.

The Telpro Panellift Plasterboard Cart is an unsafe piece of plant due to instability once they are loaded up.

The tag on the plant says it is good for between 1.3-1.8 tonne, but this is for downward load. Once the plant with load are moved, it becomes very unstable.

There is no documentation on safe use of this plant from the manufacturer.
